New York State Department of Transportation

Yellow Flag NB23T6W001

BIN: 1065318
Feature Carried: 278I278IX2M23027
Feature Crossed: 6TH AVENUE
Orientation: 8 - NORTHWEST
Region: 11 - NEW YORK CITY
County: KINGS
Political Unit: City of NEW YORK
Approximate Year Built: 1962
Posted Load Matches Inventory : Yes
Bridge Load Posting (Tons) : Not Posted for Load
Primary Owner: New York State Department of Transportation
Primary Maintenance Responsibility: 12 - State - Subcontracted to another Party
Typical or Main Span Type: 3 - Steel, 02 - Stringer/Multi-Beam or Girder
This Bridge is not a Ramp
Number of Spans: 322

This Yellow Flag No. NB23T6W001 is NEW.

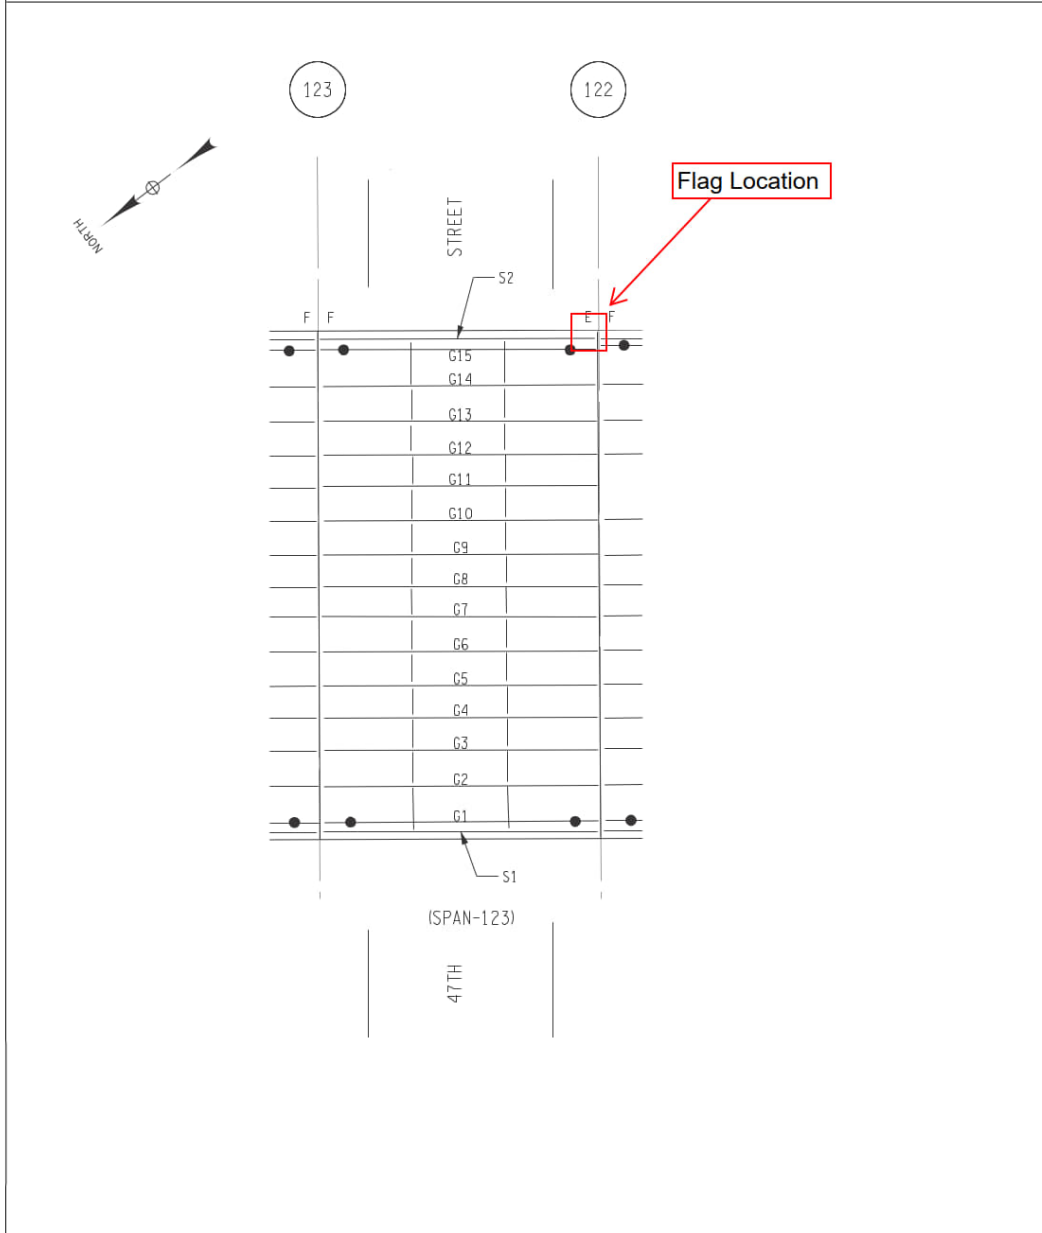
Flag PhotographsPhoto Number: **1**Photo Filename: **Span 123 Location Plan 2.jpg**Gowanus Expressway
2023 Biennial Inspection - Field SketchBIN: 1065318Team: FD/TSDate: 06/14/23Span: 123Location: Span 123

**Attachment Description: Flag Location Sketch**

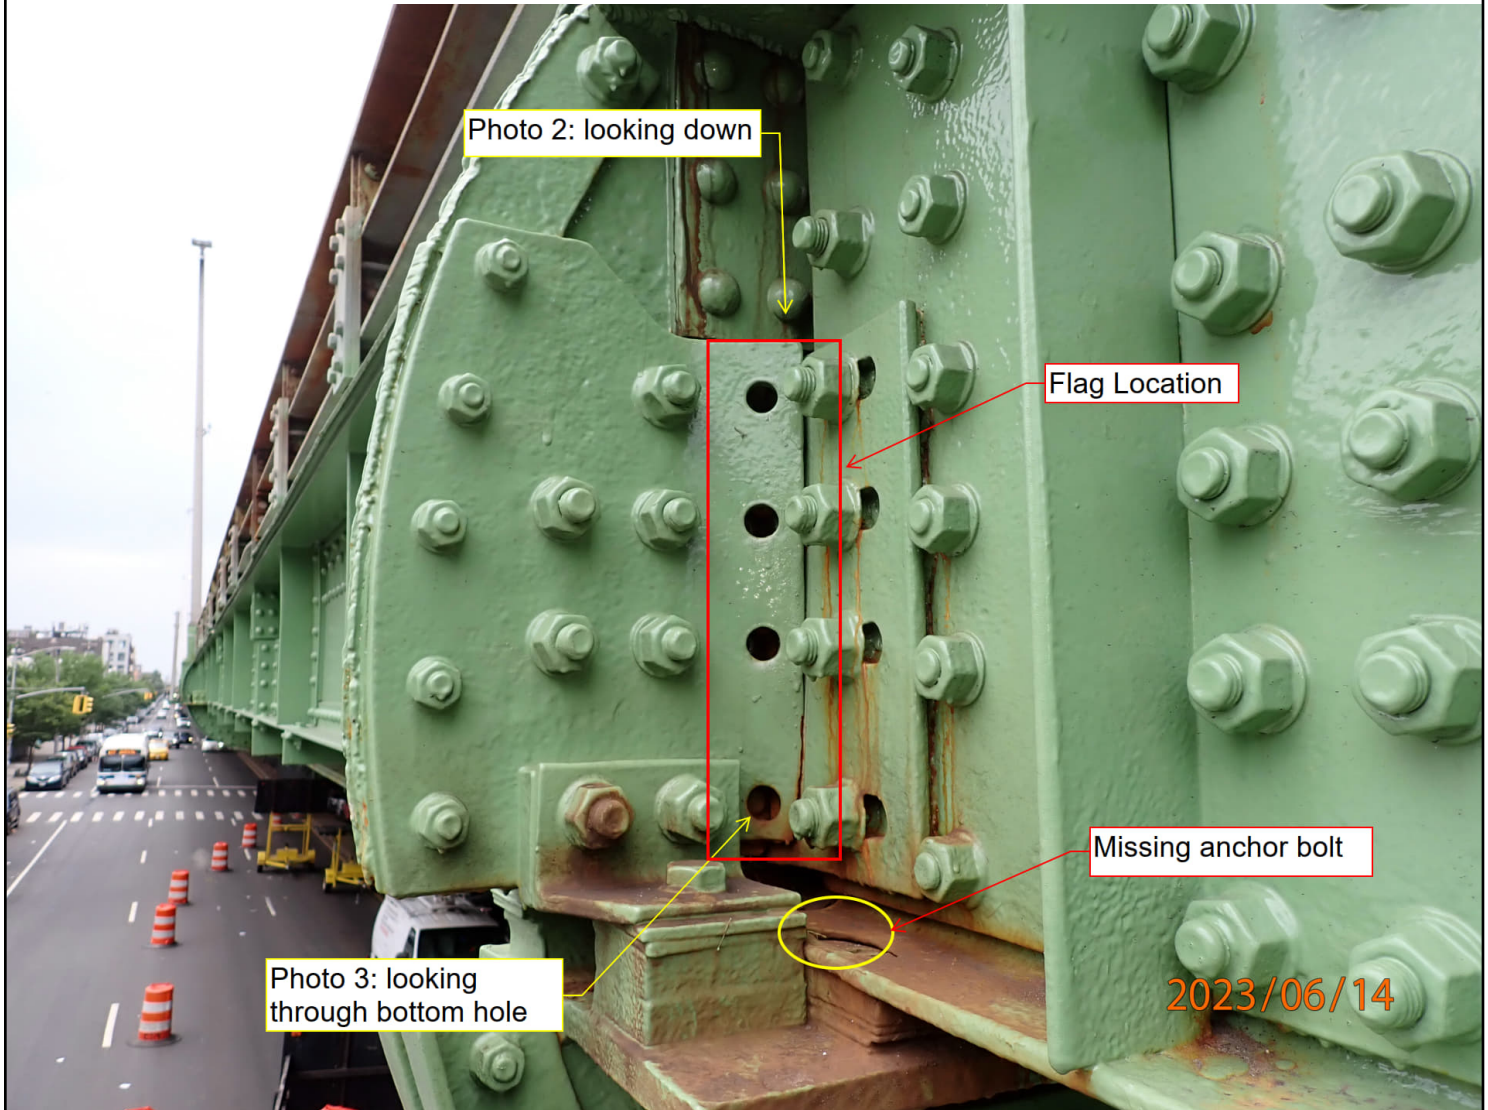
Photo Number: 2

Span 123, Stringer S2 at Pier 122 exhibits 4 of 4 missing bolts to both the left and right guide angles at the connection to the Pier 122 pier cap. (Photo #1 and #4). Additionally, the right guide angle of the previous repair, installed behind the pier web repair plate at this location, is cracked for its full height. (Photo #1, #2, & #3).

1. The cracked right guide angle (at top and at bottom), is visible from the top of the angle/repair plate looking down and from the bottom, looking thru the hole of the missing bolt of the web repair plate and is assumed to be a full height crack in this guide angle.
2. Both the left and right anchor bolts of Stringer S2 are sheared off at the bearing area. There are several double angle connections from the Stringer S2 bottom flange to Girder G15 web throughout the span length which would prevent this stringer from moving off its bearing area, therefore this is not a safety issue.
3. Stringer S2 at this location is a curb girder and receives no direct live loading, but supports the barrier/railing above on I278.

Attachment Description: Photo 1: General view of Stringer 2 right face at Pier 122. Four of four bolts are missing from the previous web repair plate and the previous repair guide angle installed behind the web plate repair is cracked for its full height. See Photo #2 for view from the top of the cracked guide angle and Photo #3 for bottom view of the cracked guide angle thru the missing bolt hole. Look Begin.

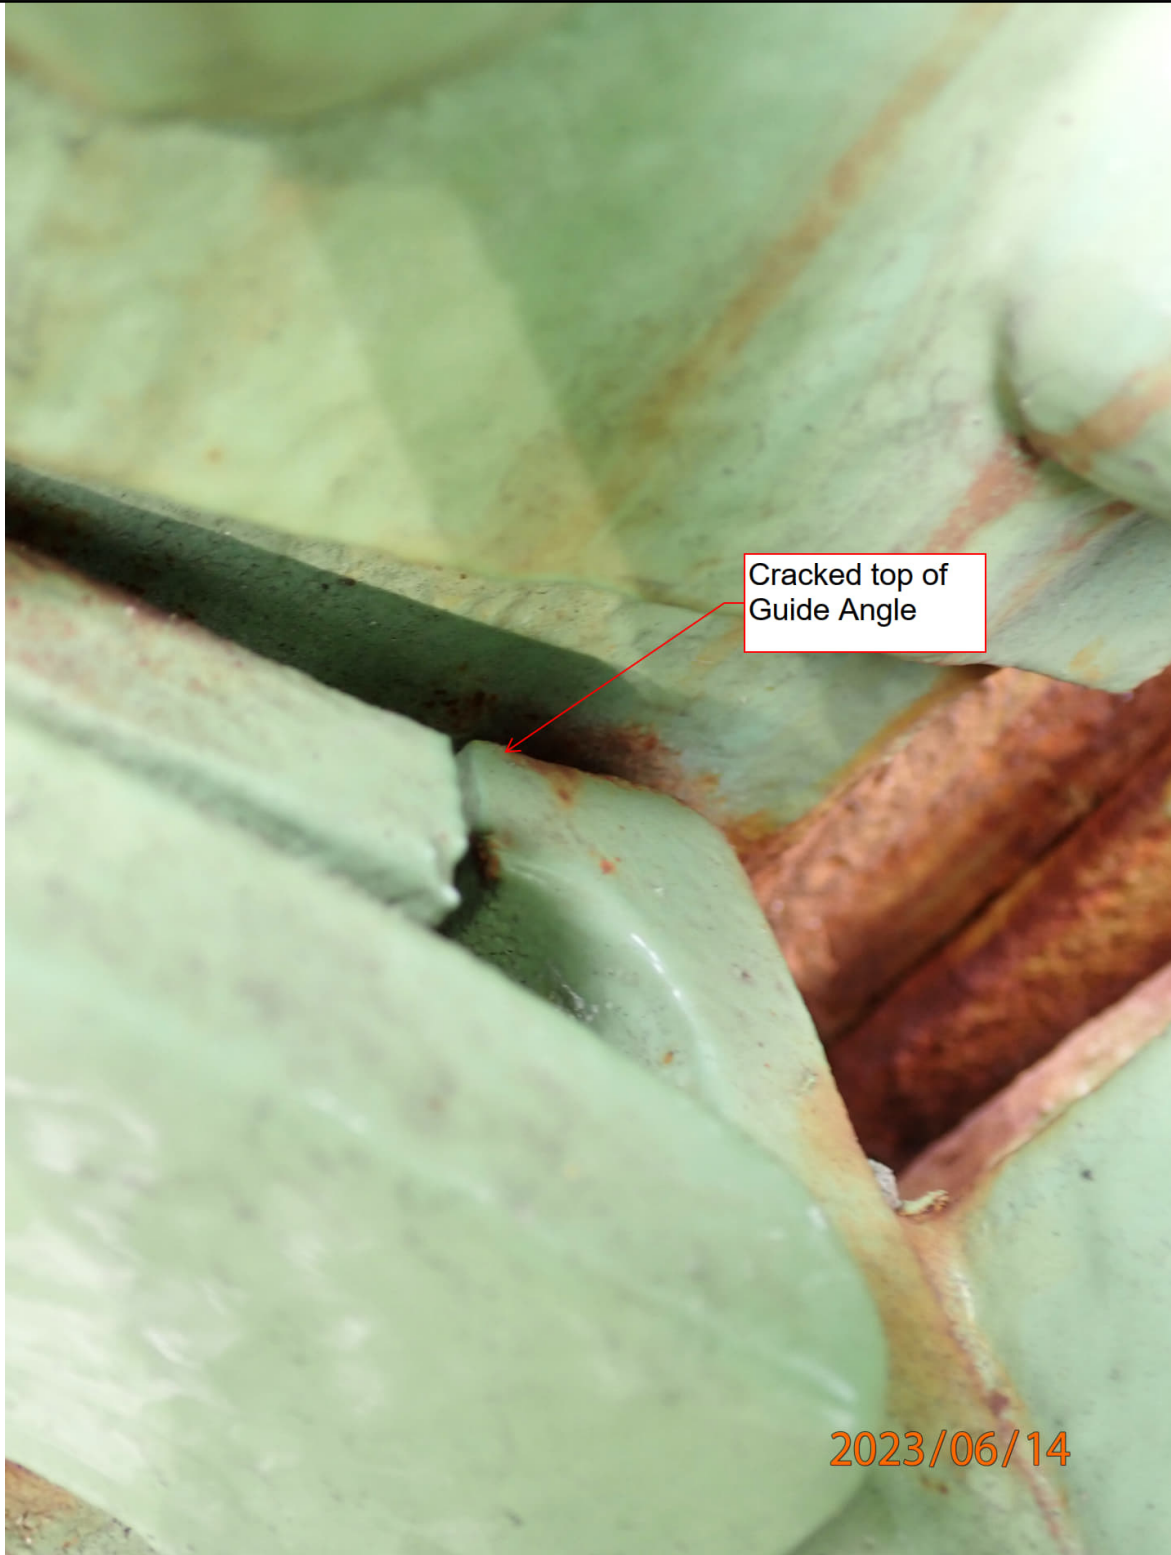
Photo Number: 3

Attachment Description: Photo 2: Close up view of Stringer S2 right guide angle with crack. Looking down from the top of the previous repair (See Photo #1).

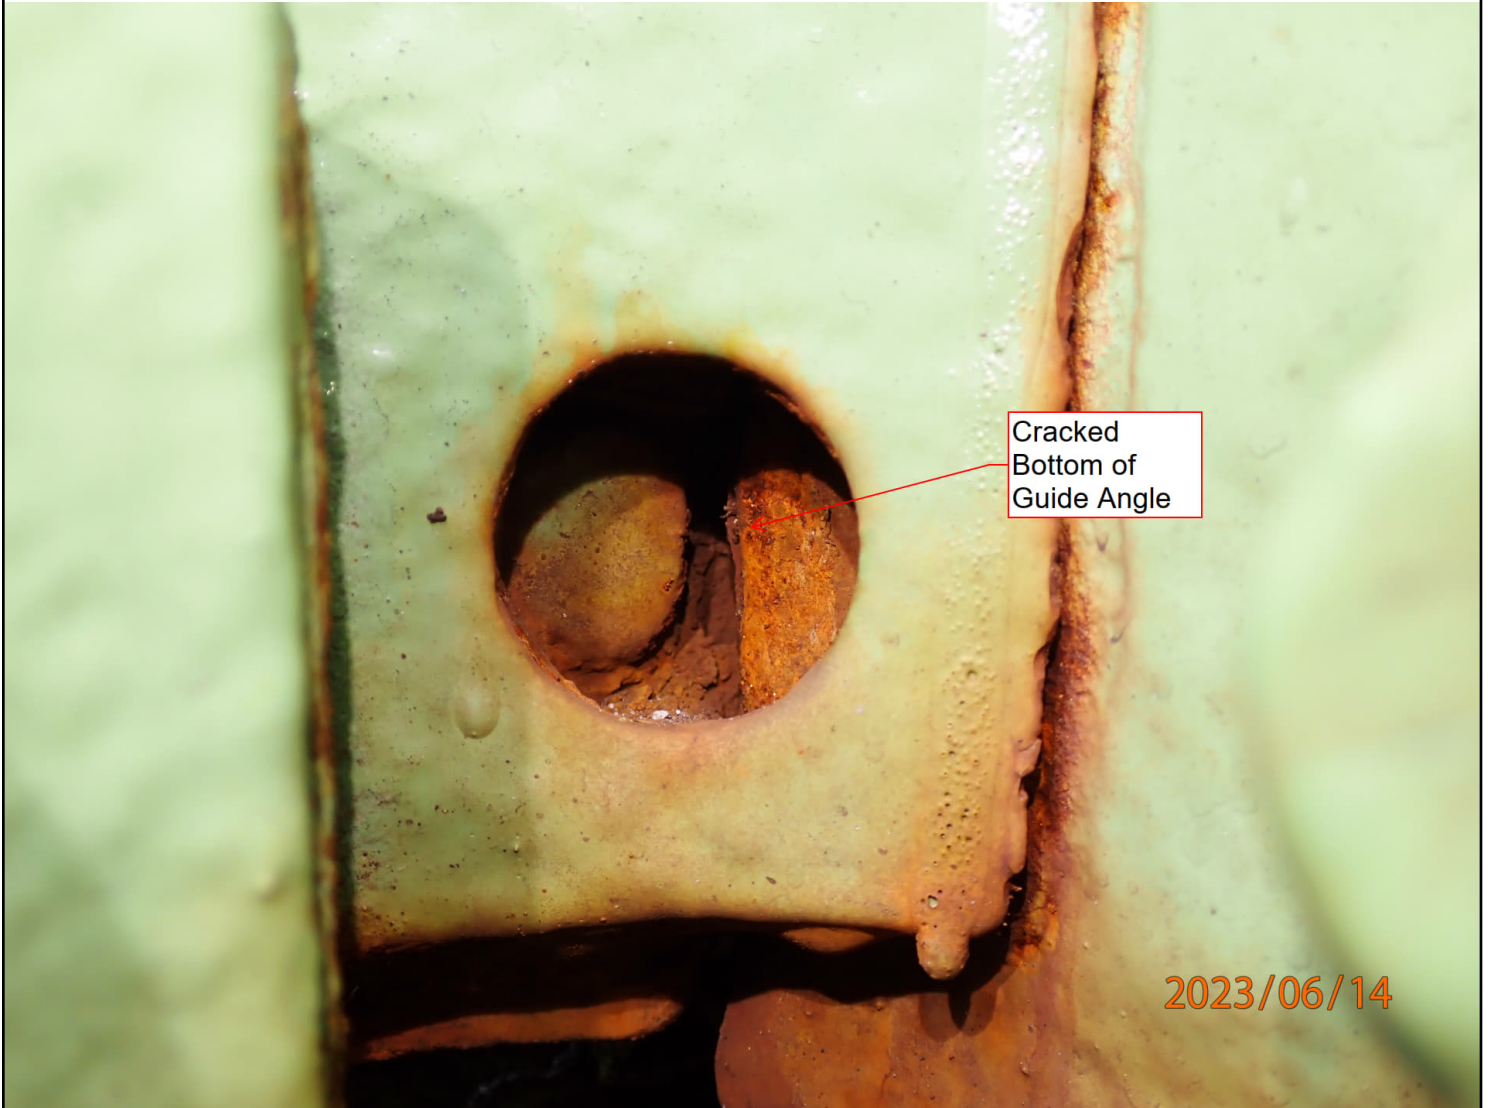
Photo Number: 4

Cracked
Bottom of
Guide Angle

Attachment Description: Photo 3: Close up view of cracked guide angle at the base, which is visible through the missing bolt hole of the previous web repair.

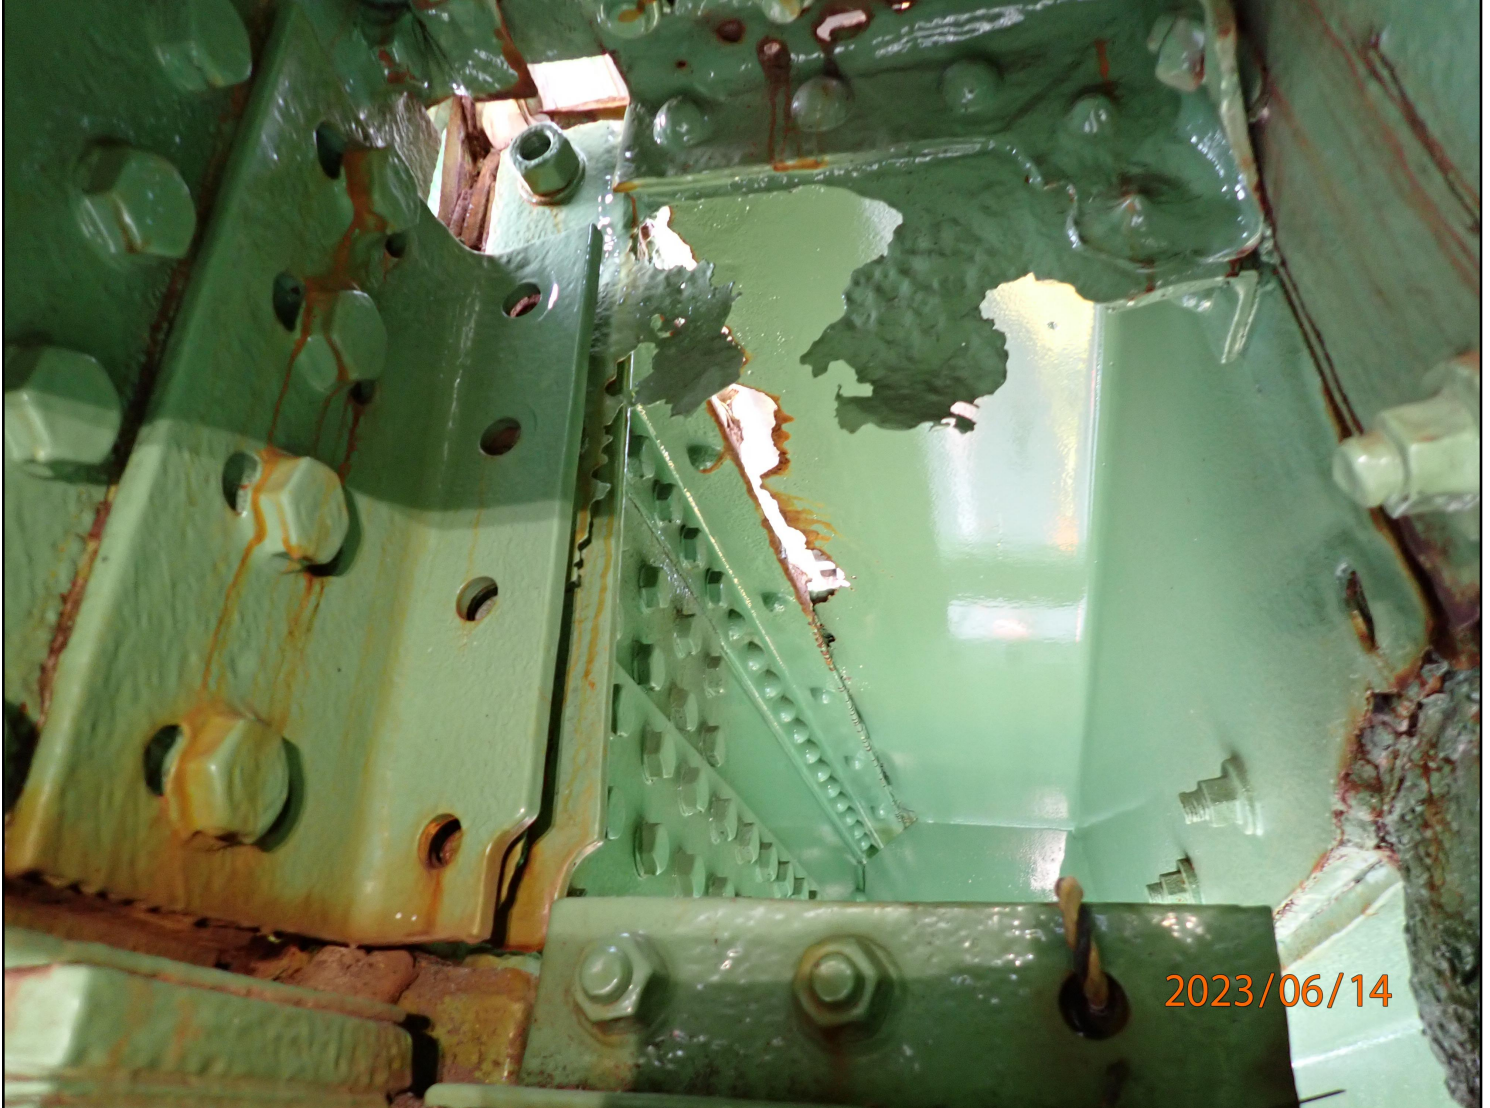
Photo Number: 5

Attachment Description: Photo 4:General view of Stringer S2 left side guide angle with 4 of 4 missing bolts. Looking Begin.
